FORD

IB150

Tech Tips

FOR APPLICATIONS SHOWN BELOW

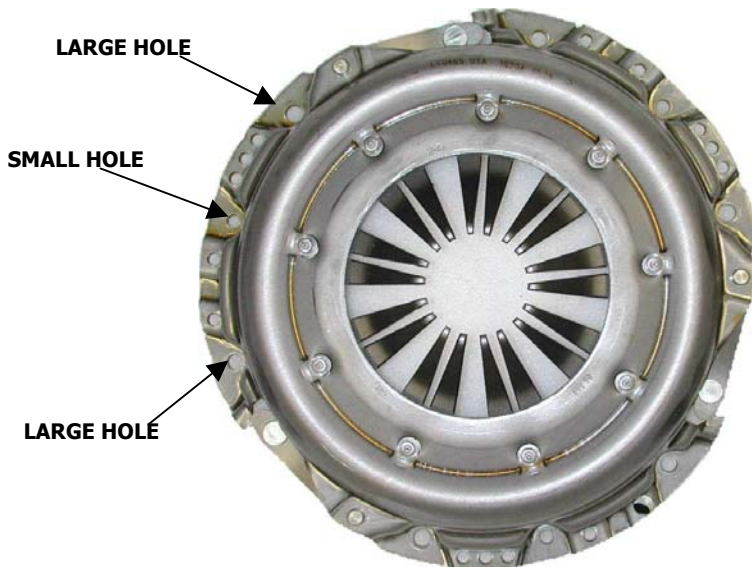
1963-77 Ford Passenger Car & Trucks

This diaphragm cover assembly is designed to replace the original lever style. The original had six bolt holes whereas this one has nine. The correct holes for mounting are one small hole and one larger hole in each group of three.

The diaphragm type cover assembly should require less pedal effort, however the vehicle may be equipped with release-assist springs on the fork and the clutch pedal. These springs are no longer needed when using the diaphragm style cover assembly and can be removed from the vehicle.

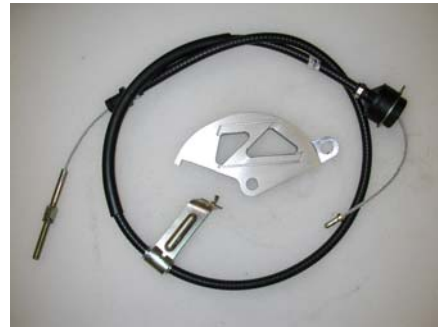
Release Cable Fatigue

These vehicles use a "self-adjusting" cable release linkage system. This type of automatic adjusting system contains a plastic pawl and quadrant. As the clutch wears the pawl and quadrant ratchets automatically to keep the clutch pedal in proper position. The plastic pieces are extremely vulnerable to bending, binding and stretching, which can cause problems with clutch release.

Ask your distributor about our Manually Adjustable Cable and Quadrant Assembly kit.

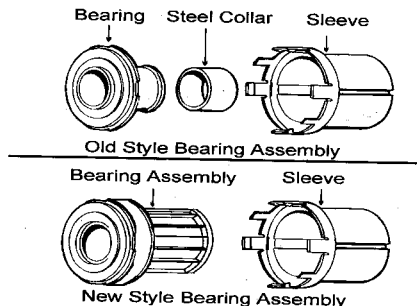
1985-87 Ford Ranger / Bronco II

Please check to be sure the piston hub spacer has been removed when replacing an old style two-piece release bearing. If it has not, then remove and discard. If it is not removed, it will cause the clutch diaphragm fingers to "overstroke", resulting in slippage and noise.

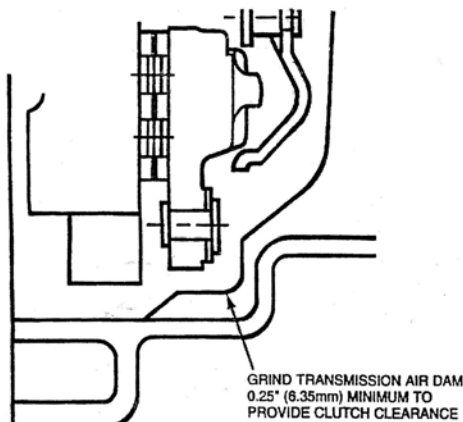
1988-95 Ford F250 / F350

Some of these vehicles may have a "ZF" factory re-man Transmission Assy., identified by a Tag # "F2TA" prefix. These units have a thicker casting in the bellhousing area than originally supplied from the factory. You may need to grind the inside of the housing approx. 1/4 of an inch for clearance. **Do not grind the pressure plate.** The area of interference is around the seven o'clock position on the bellhousing. This may actually be done by simply removing the dust cover from the housing.

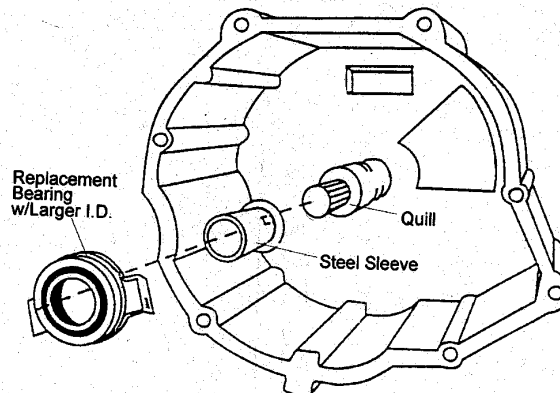
Please inspect the release bearing retainer or quill in this vehicle for excessive wear or ridges caused by the release bearing you are replacing. These ridges will cause the bearing to hang up and not slide freely, thus creating release problems.

There is an updated larger I.D. release bearing available from your distributor which includes a retainer repair sleeve to place over the worn area.

Minor wear ridges can be removed with emery paper, but a severely worn quill can only be fixed by replacing the clutch housing, as it is a machined cast part and not removable.
