GM

IB151

Tech Tips

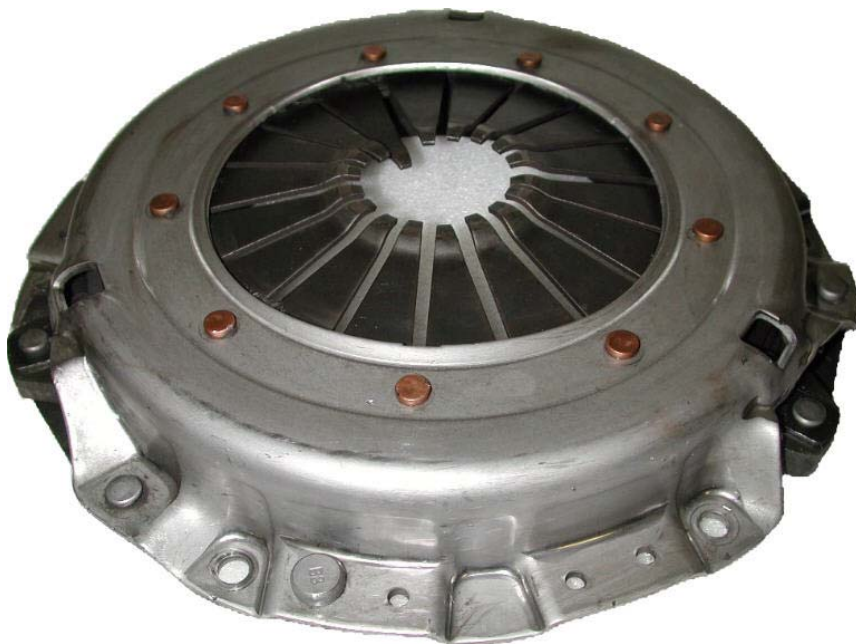
HARD CLUTCH PEDAL - HARD TO SHIFT

These vehicles were originally equipped with a metal-lined release bearing, which causes heavy galling and scoring at the contact surface of the aluminum bearing retainer. In extreme cases, the bearing retainer breaks off the transmission housing, causing the release bearing to contact the diaphragm fingers at the wrong angle and destroy the clutch. An updated release bearing with a nylon coated inner sleeve is supplied with this kit, but you still need to replace the input retainer (GM P/N 8672128).

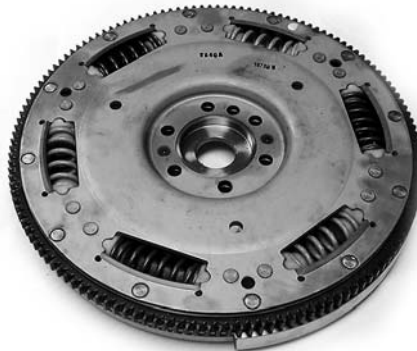
CHECKING the DUAL MASS FLYWHEEL

This vehicle uses a Dual Mass Flywheel (DMF) primarily designed to protect the transmission during high torque spikes created by the diesel engine. If you are not replacing the DMF at the time of the time of this clutch replacement, you should be aware that it is not recommended to resurface the DMF. The DMF uses a damper spring cage, just like a clutch disc, and is often the primary reason for clutch slippage. Please check it thoroughly for rattle, hot spots, or heat cracks. The plastic spring retainers on each end of the damper springs will sometimes begin to melt under excessive heat, you should make sure they are intact.

For the "mechanically inclined" there is a way to check the DMF for torque holding capacity. You will need to make a special tool you can attach to the center hub of the DMF. Use some type of drive pin that will fit in the mounting holes so the DMF can actually be bolted to the tool. There must also be a way to attach a torque wrench to your tool.

First, bolt the friction surface of the DMF to a bench (something very stationary) using the pressure plate mounting holes. Then using the torque wrench, try to rotate the DMF until it slips or you reach 440 ft. lb. of torque.

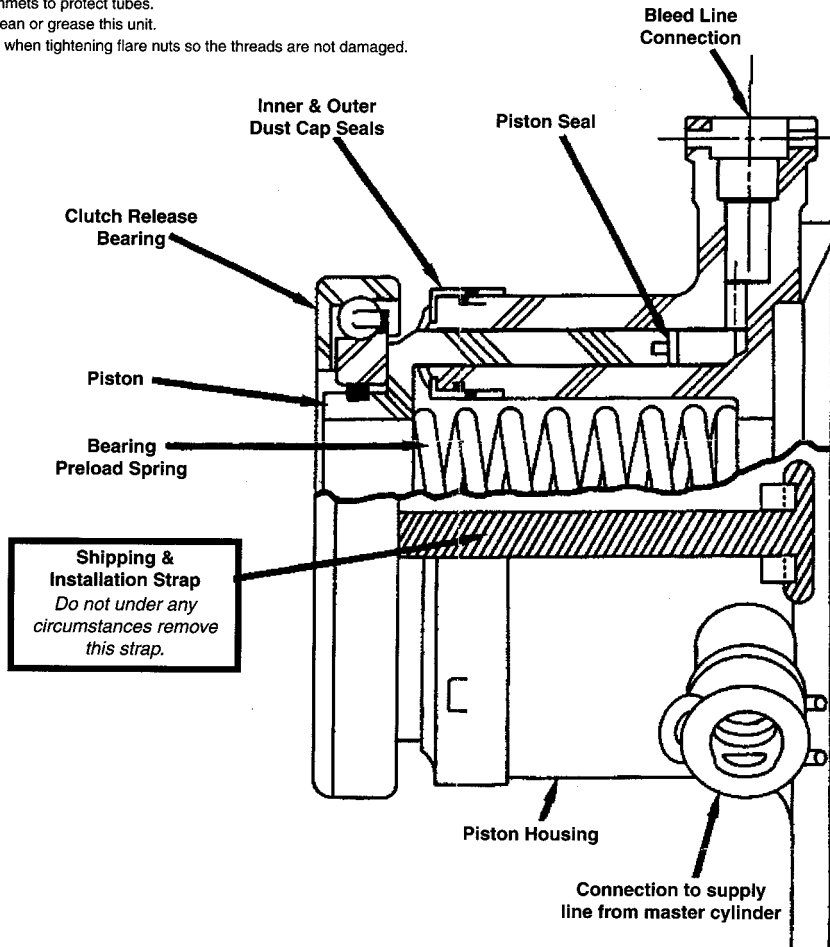
Hydraulic Clutch Assembly

Caution: Do not under any circumstances push or pull Clutch Bearing Assembly.

- 1.) Do not cut or remove straps. Piston seal damage may result. The straps are designed to break when the clutch is first actuated.
- 2.) Do not push or pull on the bearing. Piston seal damage may result.
- 3.) Use only new, clean, DOT-3 Brake Fluid.
- 4.) Bending tubes is not necessary. Do not remove tubes or snap pins. Leakage may result.
- 5.) Keep unit clean. Do not drop.
- 6.) Use grommets to protect tubes.
- 7.) Do not clean or grease this unit.
- 8.) Use care when tightening flare nuts so the threads are not damaged.
- 9.) Be sure to use the pin and retaining nut enclosed. Do not re-use existing pin and nut.
- 10.) Bleed system. Air in system prevents disengagement.
- 11.) If bearing and piston assembly is pushed out of the housing, DO NOT reassemble. Replace the unit.
