IB153

Tech Tips

***PLEASE READ THOROUGHLY BEFORE INSTALLATION OF THE
COMPONENTS IN THIS SET!***

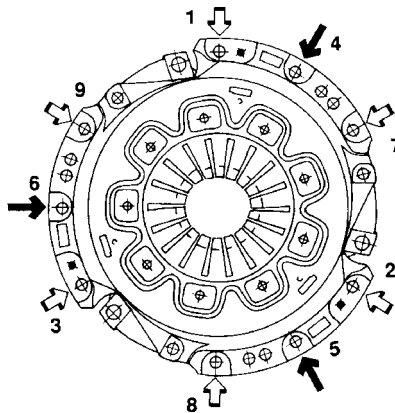
1989 Nissan Maxima

Extra Mounting Holes

Some earlier models were originally equipped with only six mounting holes.

There has been a production upgrade to a nine hole unit.

The nine hole cover assembly in this set will work even if your flywheel only has six holes. See Torque Specs

Old Holes

Additional Holes

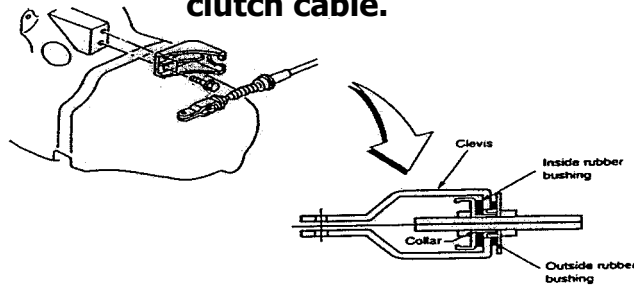
1991-92 Infiniti G20

Infiniti models produced prior to 1992 Vin Number "JNKCP01D4PT455466" may require a clutch cable replacement. Premature wear, difficult shifting and noise are symptoms of a worn clutch cable.

Check the clutch cable end at the transmission for worn or out of position rubber bushings. If there are signs of wear, the cable should be replaced with an upgraded design that came out in 1993. The part number is 30770-62J10.
